Solenoid Harnesses Damaged by Improper Removal

By Jesse Zacarias

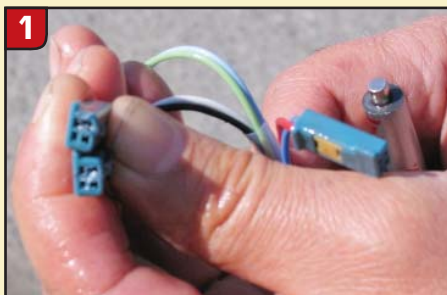
After doing valve-body repairs or replacement in Aisin Warner transmissions, some rebuilders are starting to have electrical codes that were not there before the repairs were done. I asked some of them to send me their wiring harnesses. After inspecting the harnesses I saw what I had suspected: damaged connectors. It appears that the way the harness is removed from the solenoid is damaging the connectors (**Figure 1**).

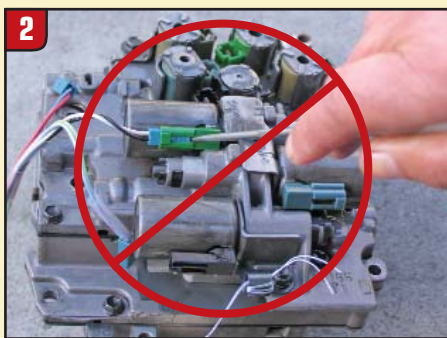
They are using a pick to remove the harnesses (**Figure 2**). You can actually see the indentation from the pick on the harness.
